# Rouge in Pharmaceutical Water Systems –

## *A rusty old habit or a manageable phenomenon?*

Author : Trevor Honeyman, CChem, CSci, MRSC.

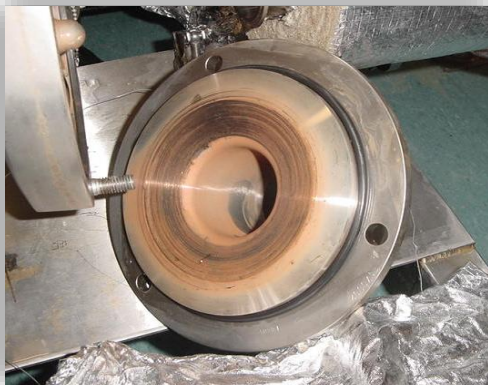
Figure 1 Example of 'rouge' found in a pump casing

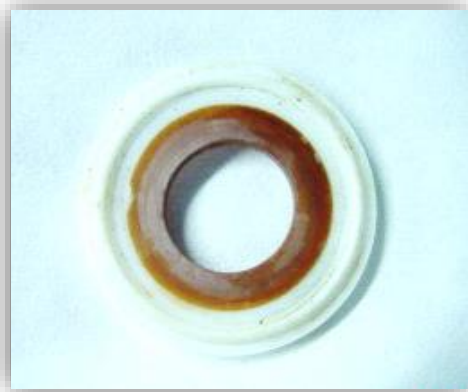
Figure 2 Rouging on a PTFE tri-clamp gasket

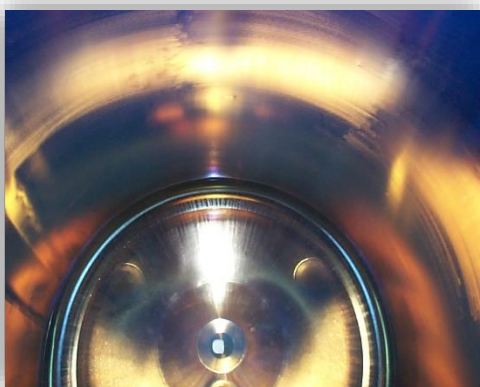
Figure 3 Rouge discolouration on the internal surfaces of a WFI storage vessel

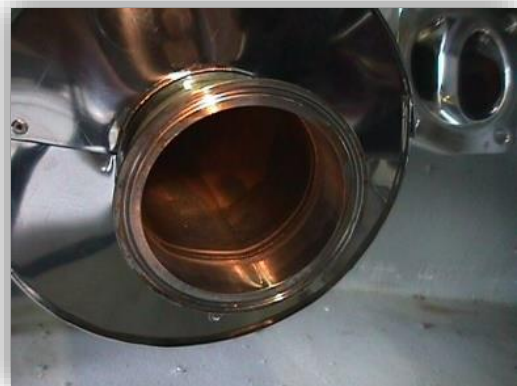
Figure 4 Rouge inside a pipe bore

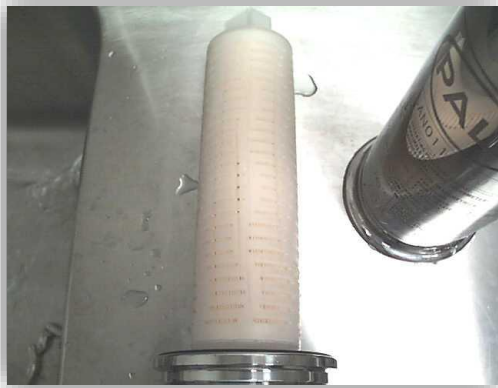
Figure 5 Rouge discolouration found on a point of use 0.45 µm filter membrane

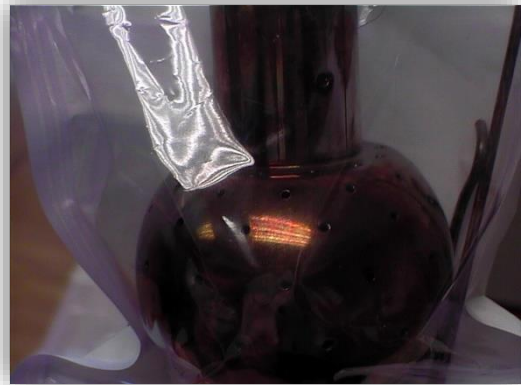
Figure 6 Vessel Spray ball (bagged)

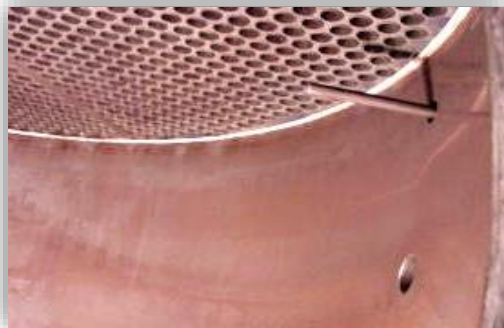
Figure 7 Bottom tubes of still

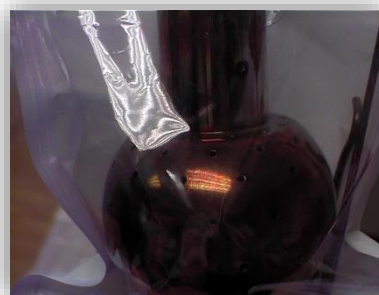
Often, the first appearance of rouge in a storage vessel might typically be seen above the water line, as may be observed through a sight glass if one is fitted. This might present first of all in the spray-ball head – a classical point of rouge formation (see fig 8). Upper surfaces of the vessel, above the water line are also visible through a sight-glass, and may also be affected. The rouging at this point is often not uniform, and can take the form of streaks or ‘teardrops’ running across the ceiling of the vessel, depending on whether or not there is a sprayball present. Spray-balls often contribute to the teardrop appearance of streaks, presumably by shedding rouge particle on to the vessel surface during operation.

Figure 8 Vessel Spray ball (bagged)

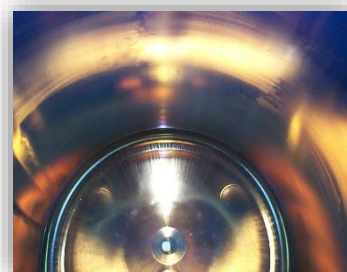
Sometimes, the rouge may be seen under the water line in the operational system. This was the case, in fact illustrated in Fig 9 in a WFI vessel. In this case, there was no change in appearance when the vessel was drained, and there was no discolouration of a cloth when these surfaces were wiped. The rouge here was not evidently present on the metal surface as described before; rather it was ‘embedded’ discolouration of the metal itself. This is more typical of discolouration of electropolished surfaces, and more akin to discolouration of metal through heating, as might be experienced on a vehicle exhaust pipe for example. This discolouration has bluish tinges, and is not dissimilar to the oil-on-water diffraction effect.

Figure 9 Rouge discolouration on the internal surfaces of a WFI storage

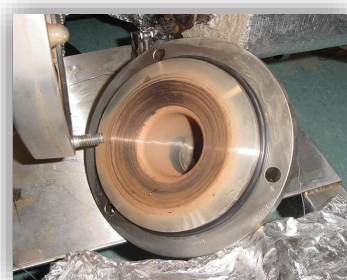
In almost every case, rouging will be evident on the internal surfaces of pump housings and impellers in heated pure water systems, as illustrated in Fig 10. This is the location where most companies first see rouge, being completely unaware of its existence until the pump is opened for maintenance inspection or repair.

Figure 10 Example of 'rouge' found in a pump casing

Again, similar to the description of rouge appearance below the water line in the vessel, the red/brown discoloration appears as a rapid bloom spreading over the surfaces of the exposed pump metal. This is commonly surface rouge, which can be removed by wiping with a cloth, but which almost instantaneously reappears whilst the metal remains hot and in contact with the air. It is generally accepted that this favourite location for rouge formation is due to the abrasive, high energy environment of the pump internals, similar to that generated in spray-ball heads.

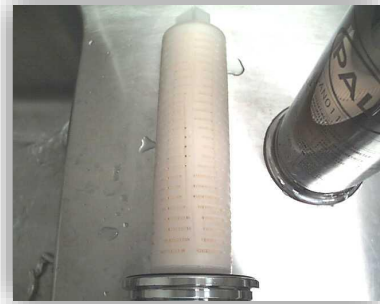
There have been occasions during early investigations where we have tried to collect migratory rouge into a 0.45  $\mu\text{m}$  filter placed on one of the water system offtakes. We found in the particular systems we were looking at, that in excess of 60,000 litres of water had to pass through the 0.45  $\mu\text{m}$  filter before there was a noticeable colour change, and much more had to flow before sufficient material could be collected even for the most sensitive chemical analysis of the deposit. This observation may be different on other systems, but does give an indication just how difficult it is to collect rouge from water circulating in a typical system with rouging symptoms.

Figure 12 Rouge discolouration found on a point of use 0.45  $\mu\text{m}$  filter

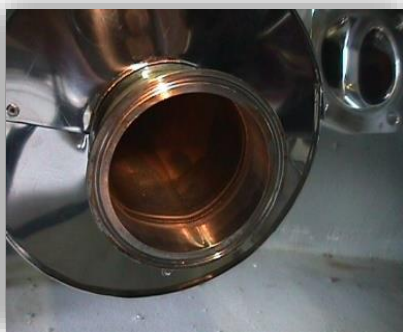
Of course, rouge discolouration may be found in many other system areas if it is looked for. These include internal pipe surfaces, as illustrated in Fig 13, heat exchangers, and especially on the internals of stills and steam generators (see Fig 14), which present particularly harsh environments in terms of temperature. It is likely that if you look for rouge in these places, you will inevitably find it.

Figure 13 Rouge inside a pipe bore

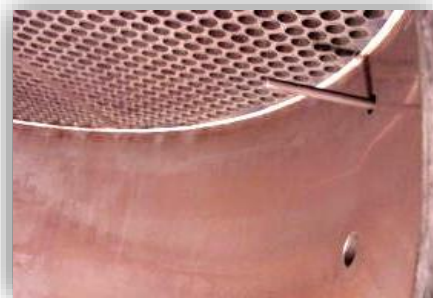
Figure 14 Bottom tubes of still
